### 3 The trouble check of TPS signal

#### 1. Troubles

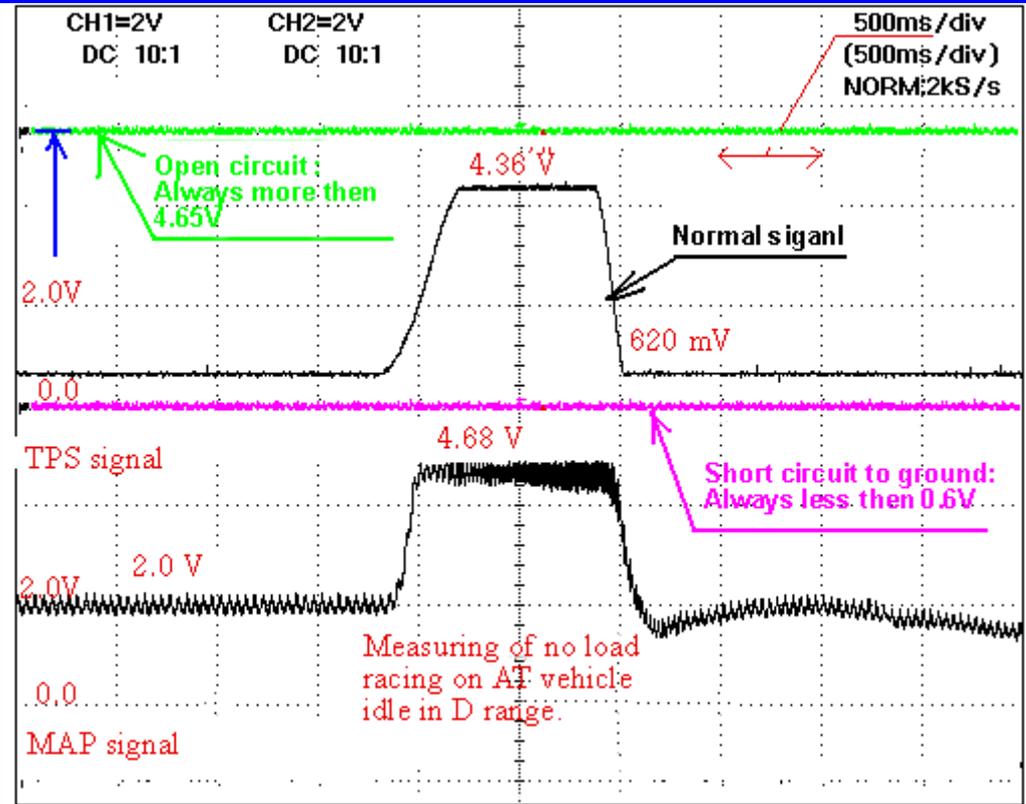
1. Malfunction of TPS sensor	
Cause of trouble	Malfunction TPS or wiring circuit failure(Signal, Ground and Reference)
Counter action	Healing by cause of trouble 1.1 TPS replace 1.2 Wiring circuit repair
Engine state	The surging is taken place when acceleration and RPM cycling is happened when recovering to idle.
Signal view

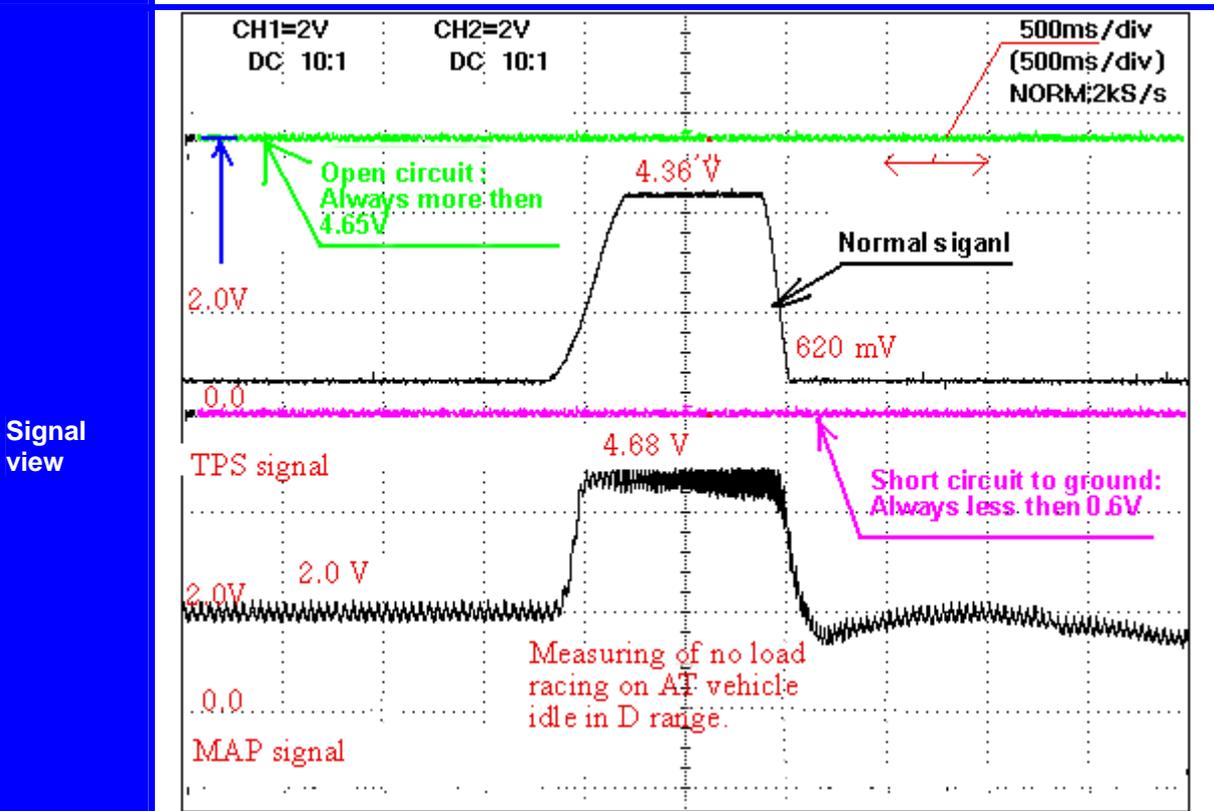
**2 TPS signal is always high (Above 4.7 V)**

**Cause of trouble**  
 Trouble detection more than one of the followings  
 2.1 Abnormal TPS (High resistance : Above 1MΩ )  
 2.2 TPS bad connecting  
 2.3 Bad connecting of TPS ground  
 2.4 Bad connecting of TPS reference line (5V )

**Engine state**  
 The surging is taken place when acceleration and RPM cycling is happened when recovering to idle.

In case that TPS signal line is broken, TPS voltage is close to 5[volt] because TPS signal line is connected with 5[volt] power supply line of "Full up" resistance.

**Counter action**  
 Healing by cause of trouble  
 2.1 TPS replace  
 2.2 TPS wiring circuit repair

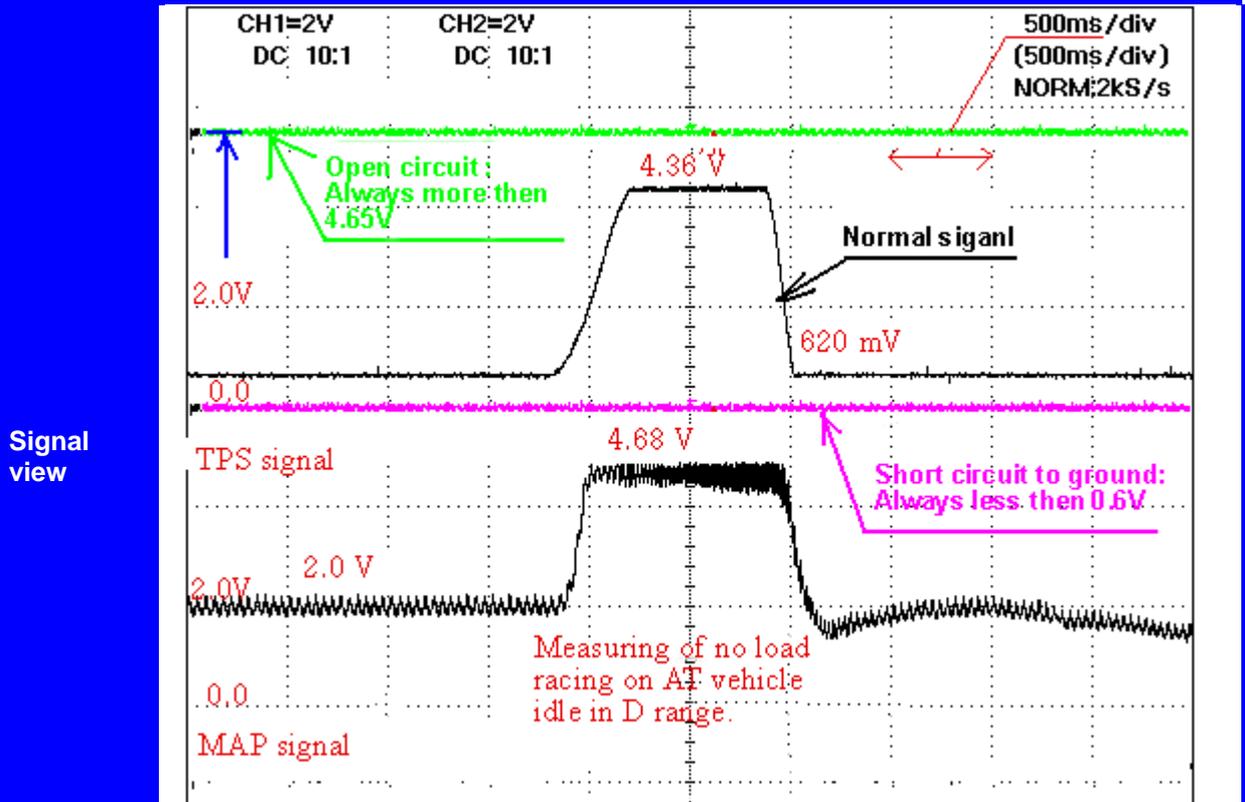
**3 TPS signal is always low(Below 0.2 V).**

<b>Cause of trouble</b>	Trouble detection more than one of the followings 3.1 Abnormal TPS (Abnormal sensing) 3.2 Bad connecting of TPS signal line or short to ground 3.3 TPS reference line (5V) short to ground
<b>Counter action</b>	Healing by cause of trouble 3.1 TPS replace 3.2 TPS wiring circuit repair
<b>Engine state</b>	The surging is taken place when acceleration and RPM cycling is happened when recovering to idle.

In idle state(Case of throttle valve closing), TPS signal is from 0.6 to 2.0[volt] range. And in case that TPS signal line is broken, TPS voltage is close to 5[volt] because TPS signal line is connected with 5[volt] power supply line of "Full up" resistance.

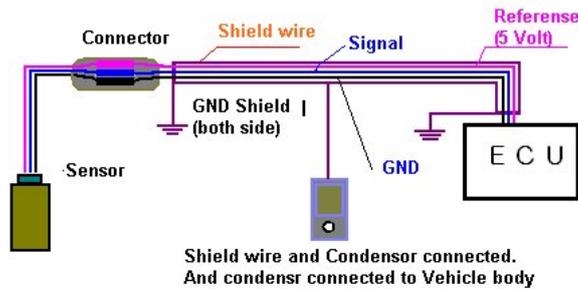
**Cause of trouble**  
 Trouble detection more than one of the followings  
 :Occur trouble during very short time(Below 100usec) and TPS adaptation value is very small at the moment  
 4.1 Abnormal TPS (Abnormal sensing)  
 4.2 TPS bad connecting

**Counter action**  
 Reset adaptation value after cleaning connector. Nevertheless, if the problem is still happened, make shielded wire as below picture.

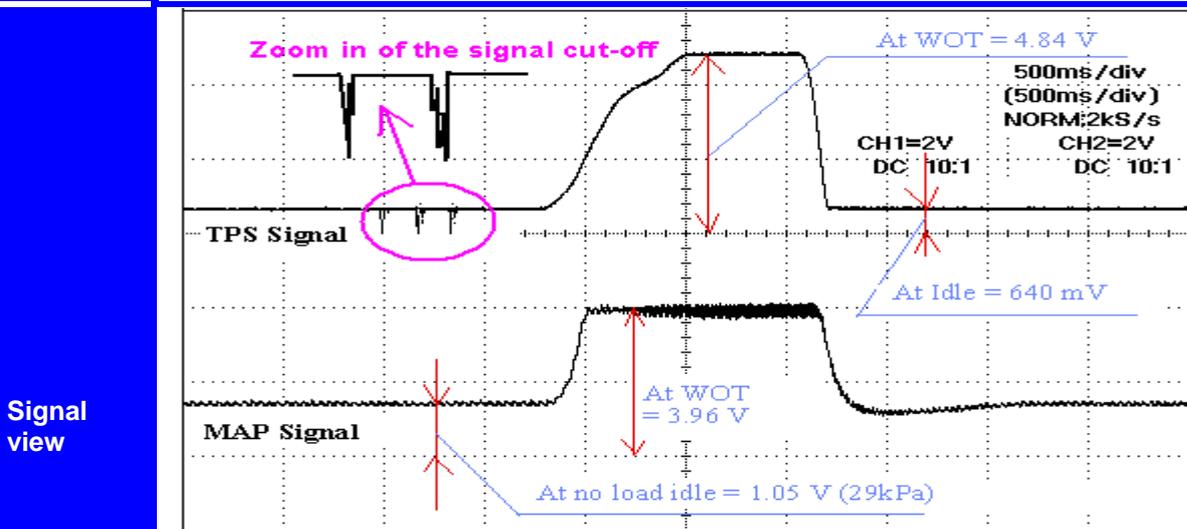
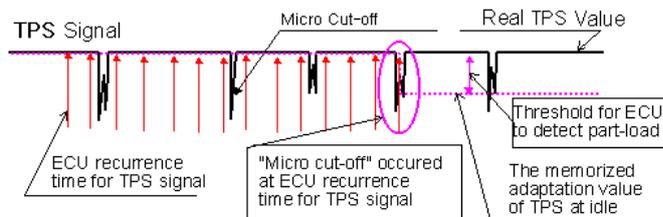
**4. Abnormal TPS signal by Micro cut-off**

**Engine state**  
 The severe engine vibration is occurred in idle state and sometimes engine stall is taken place. In case of floating occurrence, idle RPM is not returned to target.

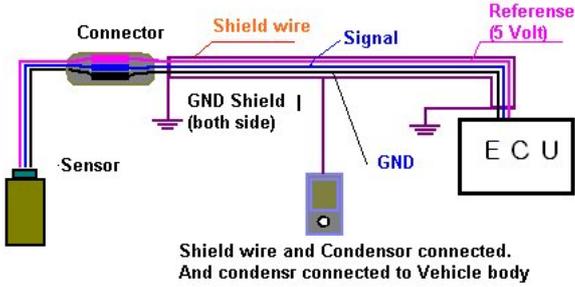
<p><b>Cause of trouble</b></p>	<p>Idle is not detected in ECU                      5.1 Abnormal return of acceleration cable                      5.2 Micro Cut-off is occurred                      5.3 Resistance variation of TPS wiring</p>
<p><b>Counter action</b></p>	<p>Healing by cause of trouble                      5.1 Replace acceleration cable if it is not normal,                      5.2 Connect directly TPS wiring(Signal, ground, reference line) from TPS connector to ECU terminal without middle connecting part (Remove resistance in wiring).                      TPS signal line should be shielded as below picture</p>

<p style="text-align: center;">Shield wire and Condensr connected. And condensr connected to Vehicle body</p>
<p><b>Engine state</b></p>	<p>1.The severe engine vibration is occurred in idle state and sometimes engine stall is taken place. In case of floating occurrence, idle RPM is not returned to target.                      2.When take off or acceleration, severe surging is happened.</p>

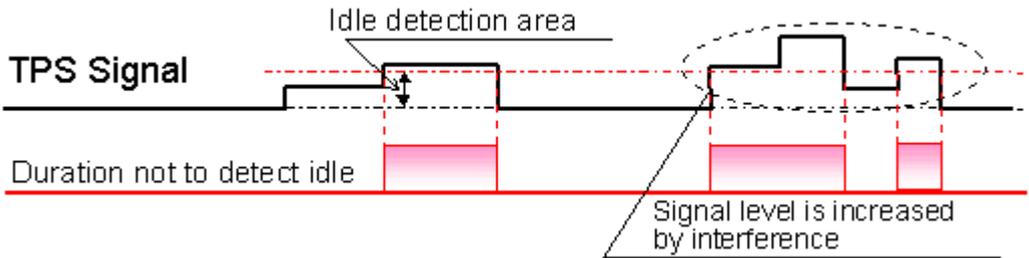
**5. Wrong idle(without acceleration)**

<p><b>Signal view</b></p>	<p>&lt; Insert Signal &gt;                      Save it as picture file after measuring signal with out of idle state by bad return of acceleration cable. And record TPS and TPS adaptation value when idle at the bottom of picture.</p>

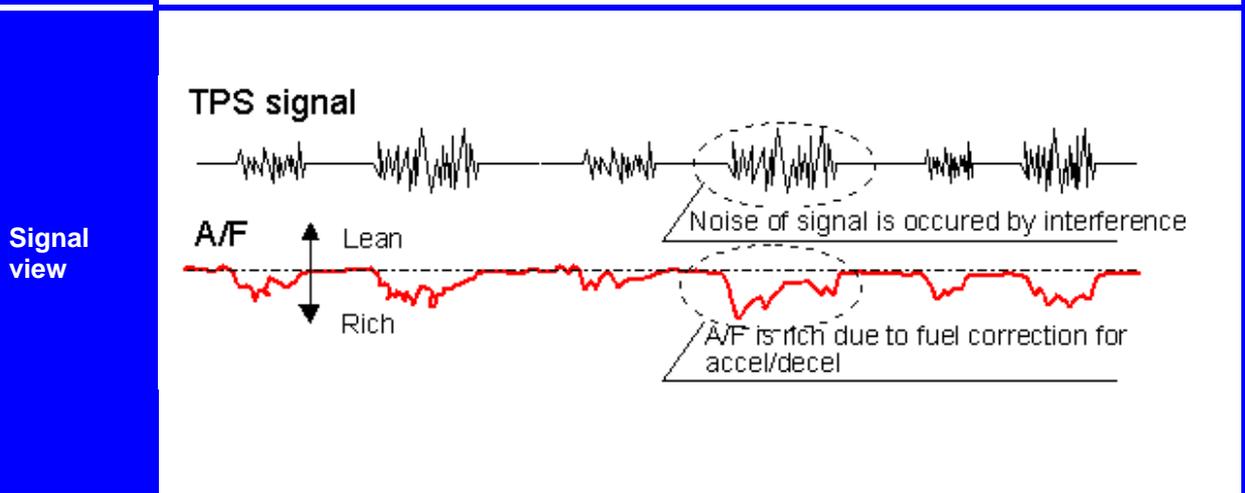
**6. TPS noise detection with idle state**

**Cause of trouble**  
 ECU recognizes continuously acceleration/deceleration for a moment.  
 6.1 It is influenced by external electric from TPS wiring

**Engine state**  
 1. The severe engine vibration is occurred in idle state and sometimes engine stall is taken place. In case of floating occurrence, engine is not returned to target idle RPM.  
 2. When take off or acceleration, severe surging is happened.  
 3. The emission may be increased too much in idle state.

**Counter action**  
 6.1 Shield wiring of ignition system and keep away from TPS wiring.  
 6.2 Connect directly after shielding TPS wiring(Signal, ground, reference line) from TPS connector to ECU terminal without middle connecting part.  
 TPS signal line should be shielded as below picture.

6.3 In case of connecting with TCU, separate it TCU  
 6.4 In case of connecting with vehicle sensor and other sensors, Do like 6.2

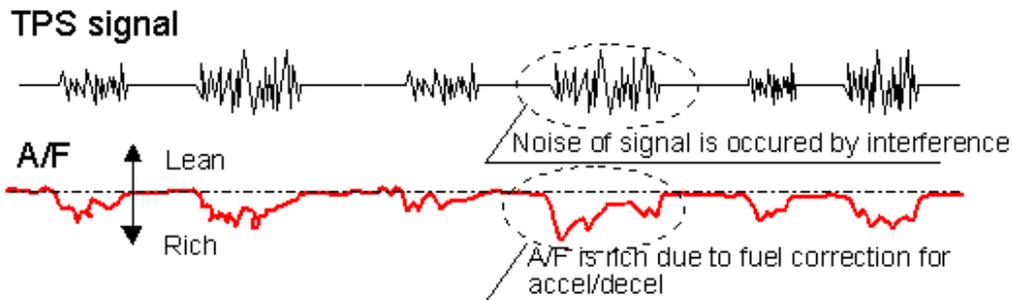
**Problem description** : RPM cycling is sometimes taken place in idle state with engine vibration. And a lot of CO emission(1.7%) comes from exhaust gas in idle state.

**Cause** : RPM cycling is taken place because ECU doesn't recognize idle state by noise detection of TPS signal. Whenever noise is detected, ECU recognizes it as working rapidly acceleration pedal. And it is cause of rich injection control as adding fuel correction when acceleration

< Rich injection control by fuel correction when acceleration >

**Explanation** : The noise is not occurred after separating TPS signal line from TCU connecting. But if it is TPS signal line which must be used with TCU connecting, noise may be reduced as separating TCU from connecting part as far as possible.

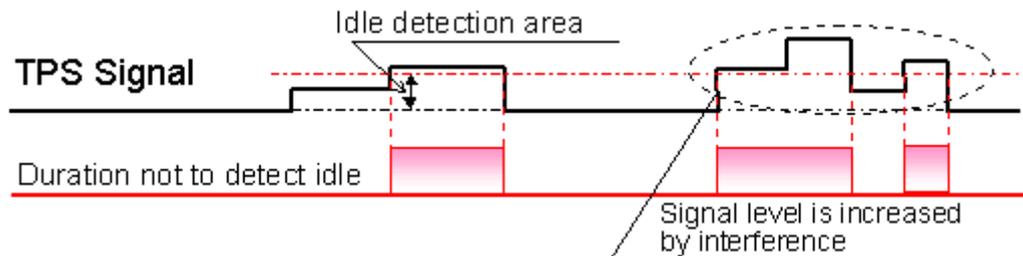
< Amplification of noise signal : ECU doesn't recognize idle state >

**Enlargement of application** : If noise is occurred in TPS signal, find what is connected with TPS signal and ground line. And check noise after separating it. If noise is reduced, remove connecting part. But if removal is impossible, find point that the lowest noise is detected as moving connecting part. Nevertheless, if noise is not decreased, find point that the lowest noise is detected as moving ground line and connect it. It may be implemented by shield line. <

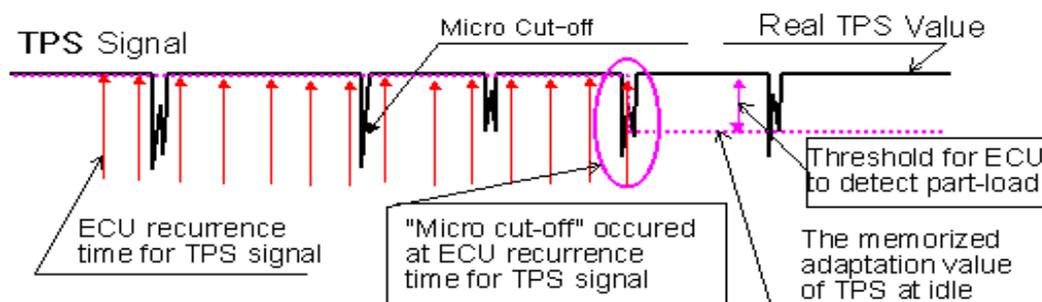
**Problem description** : Sometimes engine is rough idle state. The floating is occurred without idle recovery and surging is taken place when acceleration. TPS value that is measured from scanner is normal but TPS value is very small in idle state.

**Cause** : TPS signal is cut for very short time(  $\approx 40 - 120\mu\text{sec}$  ). ECU regard it as TPS value (Below 0.05volt) that is measured with micro cut-off phenomenon in idle state(If the idle TPS value which is memorized in ECU is less than normal one, it is set to idle TPS value). After that if it is again returned normal, ECU recognize it as working acceleration pedal and also don't apply idle correction.

**Explanation** : Finally, ECU doesn't detect idle in spite of real idle state. So, it led to rough idle. The current vehicle (Production after Jun.1996 model year) have no problem with micro cut-off (Duration is less than 0.8) because ECU change TPS value after elapsed 0.8 [sec] in case that current TPS value is less than memorized one.

**Enlargement of application** : If engine is rough idle, first compare "absolutely TPS value" with "TPS adaptation value" from scanner in idle state. If these two values have difference more than 1.2 [°TPS], ECU doesn't detect idle in spite of real idle state. So, you must find root cause after inspecting why this phenomenon is happened.

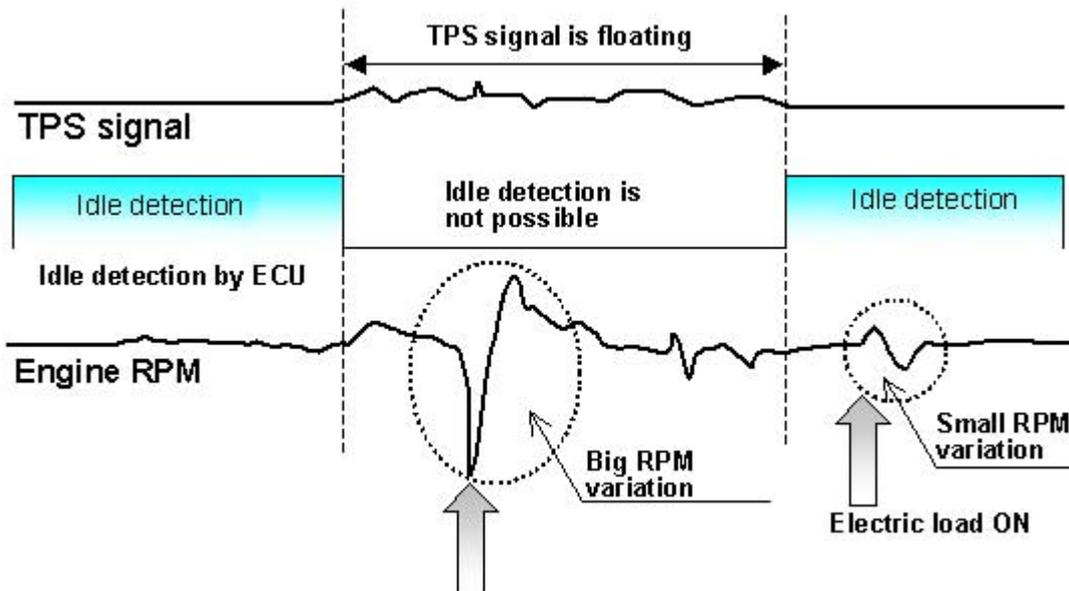
**Problem description :** Sometimes engine is rough idle state. The floating is occurred without idle recovery and severe RPM cycling is taken place with electric load or A/C ON.

**Cause :** If engine becomes so hot, TPS signal is unstable in idle state by bad connection around fuse box. So, ECU doesn't recognize idle state because the unstable signal is higher than "TPS adaptation value in idle". It results in rough idle.

**Explanation :** If RPM is unstable, the system which recognize idle by TPS signal(Without idle switch type) should check whether ECU recognize idle or not.

**Enlargement of application :** If engine is rough idle, first compare "absolutely TPS value" with "TPS adaptation value" from scanner in idle state. If these two values have difference more than 1.2 [°TPS], ECU doesn't detect idle in spite of real idle state. So, you must find root cause after inspecting why this phenomenon is happened.

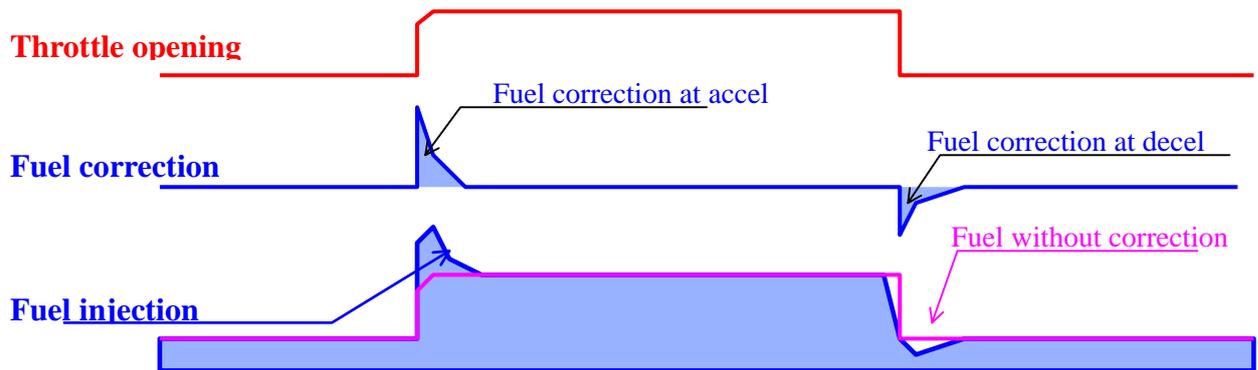
< Trouble : Impossible to detect accel or decel. >

- ▶ Big shock or hesitation during accel or decel.
- ▶ Insufficient acceleration response.

- ▶ Ignition time is retarded to reduce acceleration shock when acceleration is detected. But if acceleration is not detected then accel shock will be happened due to no ignition retard to prevent accel shock.
- ▶ Engine torque decreasing due to that additional fuel to compensate wall film during acceleration is not supplied.

Move TPS and check if real signal value is moving. The problem of constant signal due to line break or short circuit can be detected by ECU self diagnosis and if you connect Hi-scan, you can find the root cause.

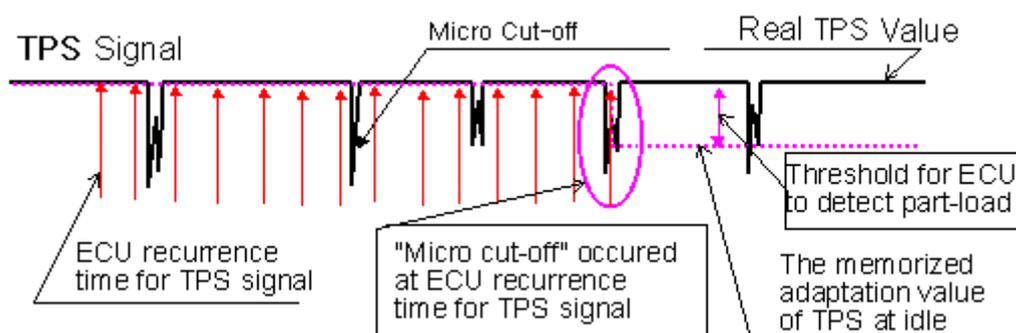
< Figure 3 : TPS signal micro cut off >

- ▶ If and TPS signal is suddenly goes down to 0V and adapt it as idle state and then back to 1.0V again after 1.0V has been adapted as idle state, what will be happened?

In this case, 1.0V of TPS pedal pushing is detected and will make above problem.

=> Actually, TPS signal micro cut off can be happened but the root cause is still not found out and counteractions are just to improve connection conditions of TPS connector and to change logic. For example, if TPS value is decreased very fast, ignore current value but use previous value. As it is difficult to improve above problem in the filed, ECU must be change with new improved logic.

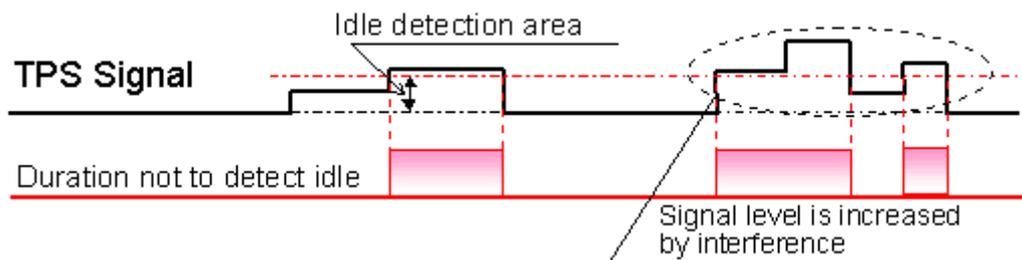
< Figure 4: TPS signal is floating by external influence >

► In case of that idle state is not detected due to higher signal voltage by bad TPS ground condition TPS, engine speed must be within normal range (below 1200rpm) to adapt current TPS value as idle data. But what if idle speed is higher than 1200rpm or what if engine is stalled? In that case, as TPS have no chance to learn idle state, above mentioned problem will be happened intermittently (especially with overheated engine, or with hot weather ).

=> In fact, if idle detection is failed during idle state, engine speed can be higher than idle speed. Because, spark advance is set to MBT(Maximum spark advance for Best Torque ) out of idle area. Even though air quantity to the cylinder is same, engine speed increase with higher spark angle. (Remark: 10-15rpm per 1deg of spark angle.). Therefore if TPS value is bigger than adapted value and engine speed is higher than idle then ECU detect as pushing throttle pedal. In some cases, engine can be stalled. In this case, besides of engine speed increase by spark advance, engine stall can be happened due to no compensation for the electric load.

The counteraction for this is that if other component uses same ground line with TPS, then separate TPS ground line and ground it separately. And check TPS connector condition.( best action is to connect all TPS line : Signal, ground and reference line from TPS to ECU directly).

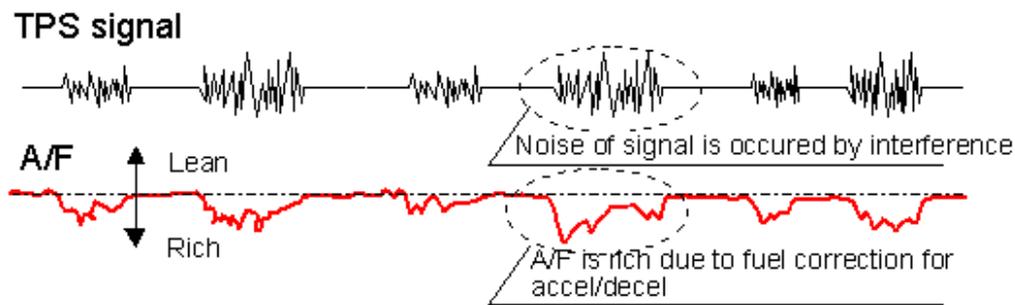
< Figure 5: TPS noise >

► In case of noise on TPS signal, how ECU can avoid wrong detection of this noise signal as real throttle pedal movement? What if accel and decel compensation is happened by this noise?

=> This problem also can be happened well. Especially, if TPS signal is used for other functions(TCU ), this problem can be happened.

In that case, it do not give any influence to the driver but high emission or engine noise at idle can be occurred.

The counteraction for this problem is to connect all TPS line : Signal, ground and reference line from TPS to ECU directly.

But if TPS line is shared with TCU (Transmission Control Unit) then find good ground connection location between ECU and TCU where shows less noise. ( This action is for car body electronic engineer but if there are many accessories installed by owner(audio...), it is same )
