7. The signal check of ignition system

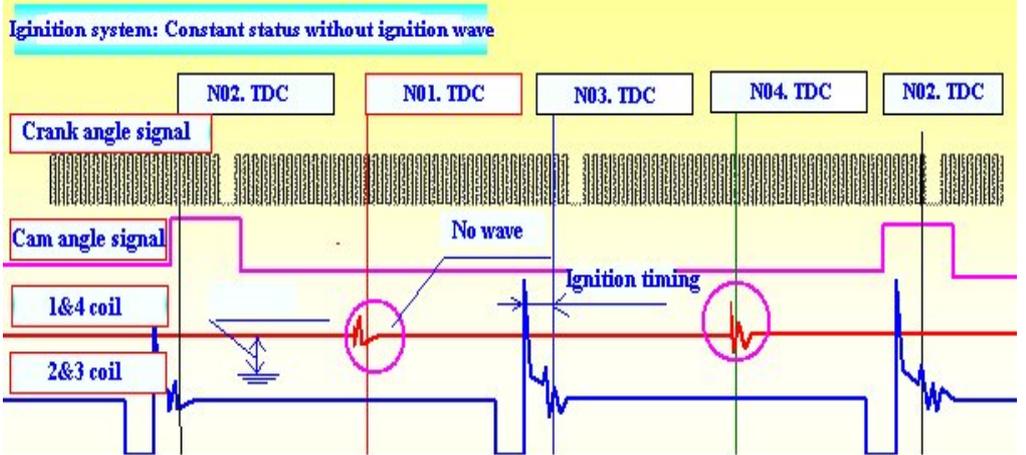
1. Power line off of ignition system	
Cause of trouble	1.1 Power supply line break of ignition system 1.2 Malfunction of parts or system for ECU internal ground
Counter action	1.1 Repair power supply line to be broken 1.2 Damage of ECU internal parts due to short to battery of line between ignition system and ECU a. Look for short to battery location and repair it b. ECU replace
Engine state	Engine is hard to start. And even if engine is started, severe engine vibration is occurred and it is stalled soon. Surging is detected when acceleration.
Signal measurement	<p style="color: red;">Trouble of "Check part 1":</p>

<p style="background-color: #FFFF00; border: 1px solid black; padding: 2px;">Ignition system: Constant status without ignition wave</p>

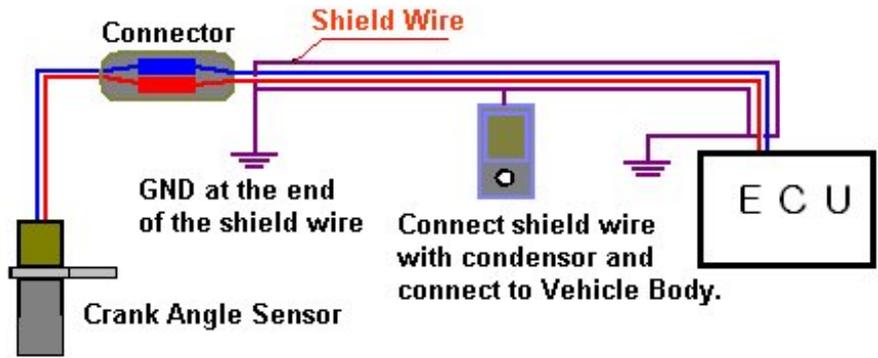
2. Incorrect spark advance

Cause of trouble
 2.1 Crank angle signal noise.
 2.2 Abnormal long tooth detection by abrupt piston speed reduces.

Engine state
 The severe engine vibration is occurred and RPM variation is too fast. Engine is intermittently stopped in idle state, especially in case of LPG vehicle, severe backfire is happened with acceleration.

Counter action
 2.1 Prevent CAPS signal noise detection.
 a. Shield crank signal line to 3 [cm] front of ECU.
 b. Shield wiring of ignition system.

2.2 Adjust air gap between crank angle position sensor and flywheel. Specification of air gap : 0.5 ~ 1.5 [mm]
 < Reference >
 In case of heavy acceleration with low vehicle speed and high gear shift, It can be intermittently occurred. In this case, the phenomena may be decreased by shortened air gap but it is not basic solution.

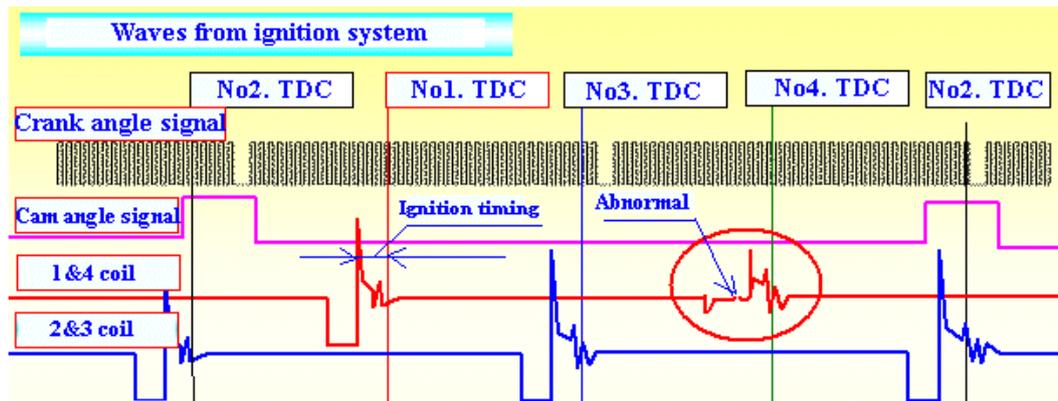
3. It is not abnormally ignited

- 3.1 Number of crankshaft short teeth is not correct.
- 3.2 The acquisition of long tooth signal is wrong

Engine is stopped or stable after severe engine vibration during idle state and surging is happened with driving.

- 3.1 Prevent CAPS signal noise detection
 - a. Shield crank signal line to 3 [cm] front of ECU
 - b. Shield wiring of ignition system

- 3.2 Adjust air gap between crank angle position sensor and flywheel.
Specification of air gap : 0.5 ~ 1.5 [mm]

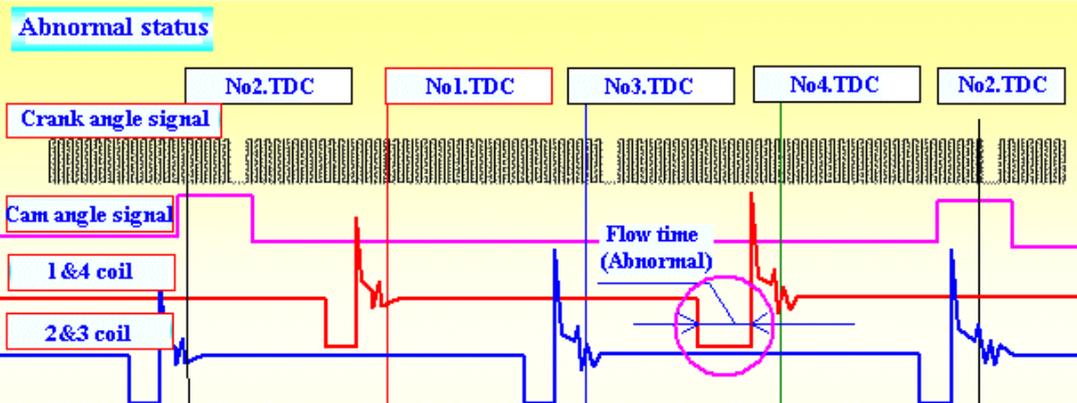
4. Incorrect dwell time (Dwell time)	
Cause of trouble	<p>4.1 Voltage variation of wiring reading battery voltage in ECU is too frequent.</p> <p>4.2 Occasionally, voltage variation of wiring reading battery voltage in ECU is too frequent for short time.</p> <p>4.3 Number of crankshaft short teeth is not correct.</p> <p>4.4 The acquisition of long tooth signal is wrong.</p>
Counter action	<p>4.1 Remove a factor which give resistance variation in wiring reading battery voltage in ECU</p> <ol style="list-style-type: none"> In case that ECU pin number V7 is connected with key box (IG1), connect directly to Battery plus(+) terminal. In case of exception a, if there is wiring to supply into device non-related to electronic control in wiring connected with ECU pin, connect after separating it from ECU pin wiring. <p>4.2 If a and b case are excepted, the extra case is abrupt overload in parts connected with ECU pin. Therefore improve it.</p> <ol style="list-style-type: none"> Inspect whether it is overloaded on brake lamp. Inspect whether it is overloaded on cooling fan Inspect whether it is overloaded on air conditioner motor or clutch. Abruptly overload on fuel pump. Overload on after main relay terminal for short time. <p>< Reference > This phenomenon is occasionally occurred and also brings surge. Replacing of its after finding troubled part through auto scanner may decrease the problem but actually it is so difficult to solve the problem.</p>

Engine state	RPM is unstable and in case knock sensor equipped vehicle ignition is retarded due to heavy knocking detection. It results in bad fuel economy and performance.
Signal measurement	<div style="background-color: yellow; padding: 10px;"> <p>Abnormal status</p>

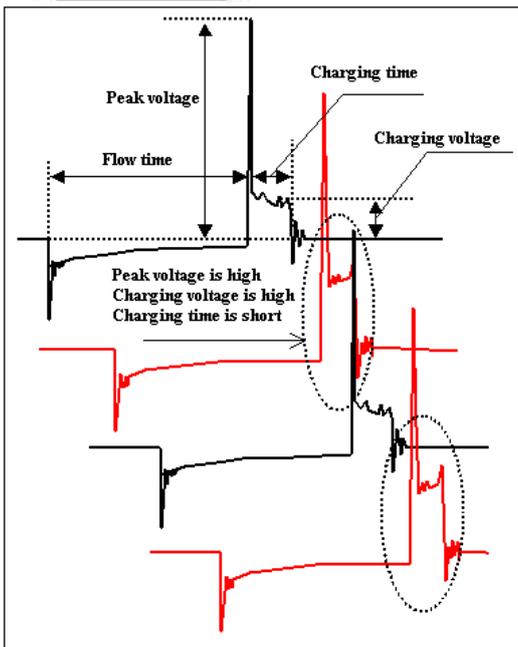
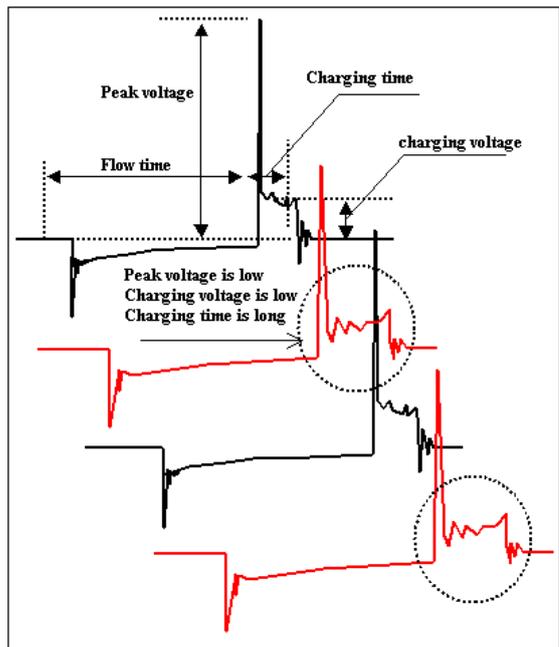
5. Ignition coil primary over voltage duration is different between individual cylinder

Cause of trouble
 5.1 The gap of spark plug tip is different or tip is contaminated
 5.2 The compression pressure is different
 5.3 The secondary coil is abnormal..

Left case: The gap of plug tip is too wide or secondary ignition system has big resistance.
 Right case: The gap of plug tip is too narrow or exist factor of cause inside combustion chamber as rich mixed gas or low compression ratio.

Counter action
 5.1 Inspect spark plug. If it is abnormal, replace it
 5.2 Compare compression pressure of individual cylinder and repair cylinder which compression pressure is abnormally measured.
 5.3 Inspect whether the current of ignition coil is $6 \pm 0.5A$ or not. If it is out of range, check ignition coil and wiring.
 5.4 Compare ignition coil primary over voltage duration between each cylinder. And repair cylinder which is measured big difference for peak voltage / duration voltage / duration time.

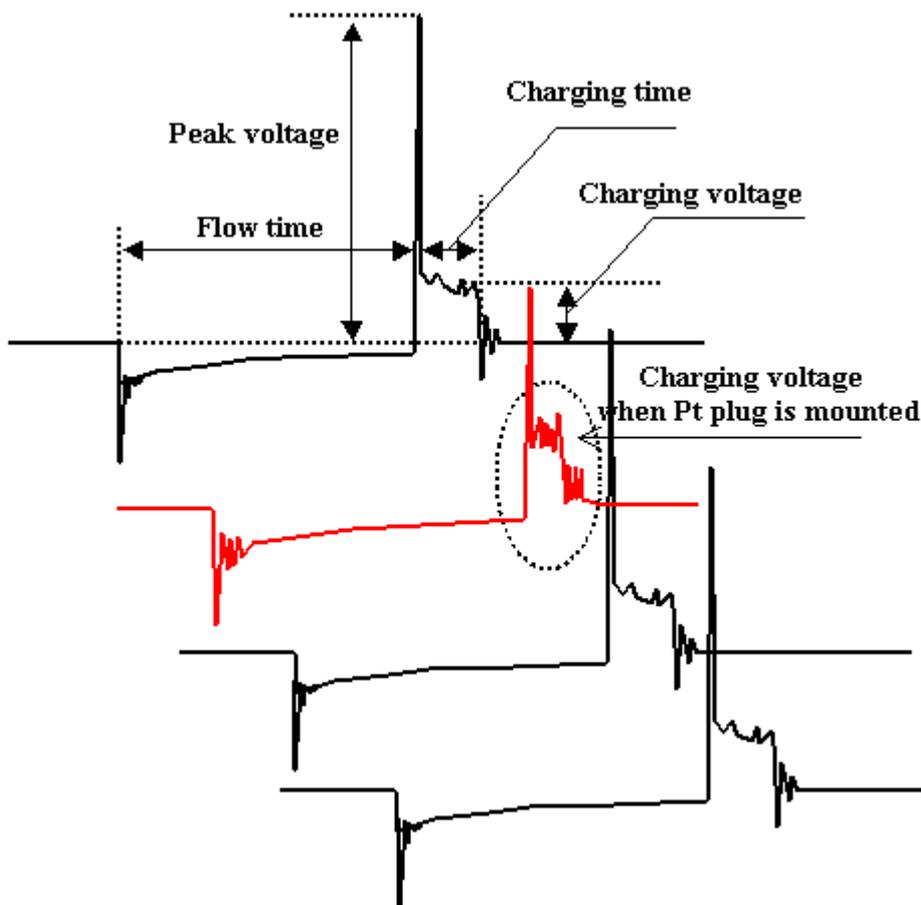
< Example 1 >

Problem description : The vehicle which platinum plug is equipped has poor performance when acceleration, black color of exhaust gas and engine is hard to start in cold ambient condition.

Cause : There was no problem in platinum spark plug but plug that is used in high temperature condition(For racing car) was equipped. Therefore it led to insufficient secondary ignition fire with too low tip temperature.

Signal measurement : In case of using all of platinum spark plug, secondary ignition signal is normal. But it has big difference after replacing original plug(Heat value No.7).

Explanation (Analogical interpretation) : The resistance is low because tip is not heated easily with platinum plug of cooling type. So, peak voltage is circulated into plug tip before discharging heat electron from fuel and discharge voltage is a little bit high because resistance of tip is bigger than discharging through a electron from fuel.

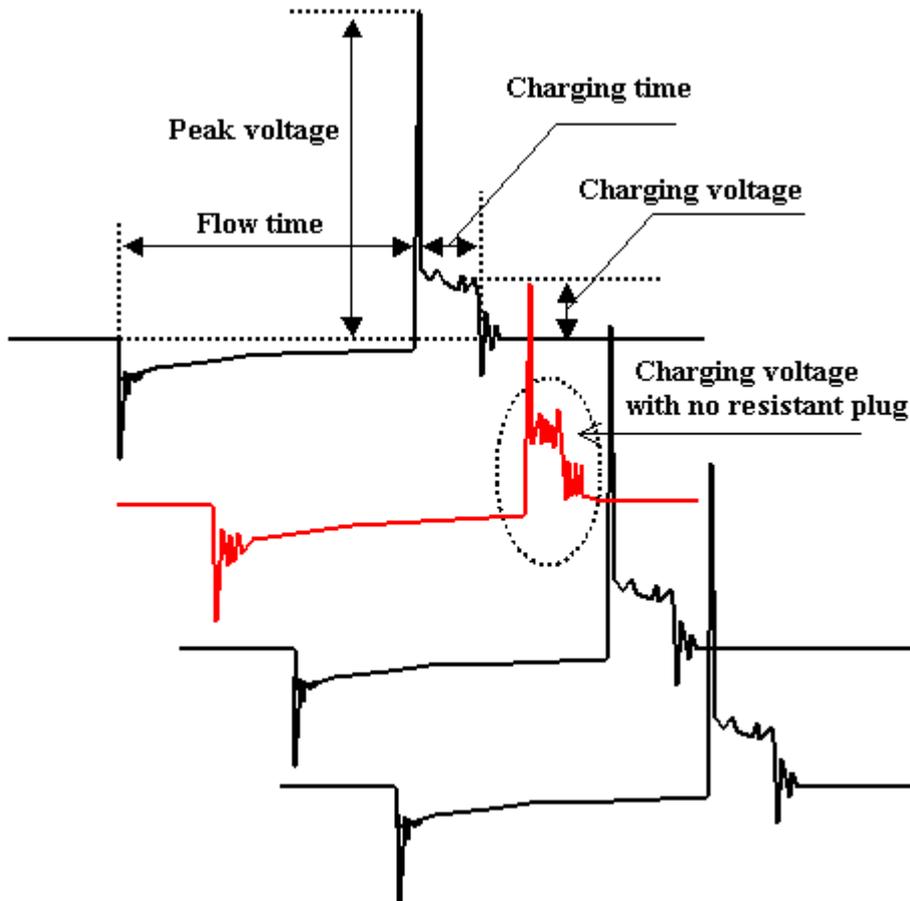
< Example 2 >

Problem description : Engine is stopped with starting and restart is hard. After elapsed long time, engine is started but stopped soon.

Cause : The spark plug has no resistance. After discharging as using it, big noise is happened and influence to ECU. It makes a mistake in ECU.

Signal measurement : After discharging, oscillation of ignition signal is big and long comparing to normal. It has big difference comparing to plug of other cylinder.

Explanation : The secondary ignition is factor to generate the biggest noise in vehicle. This example prevents normal operation of ECU. But it also may make noise into other component and actuator for electronic control.

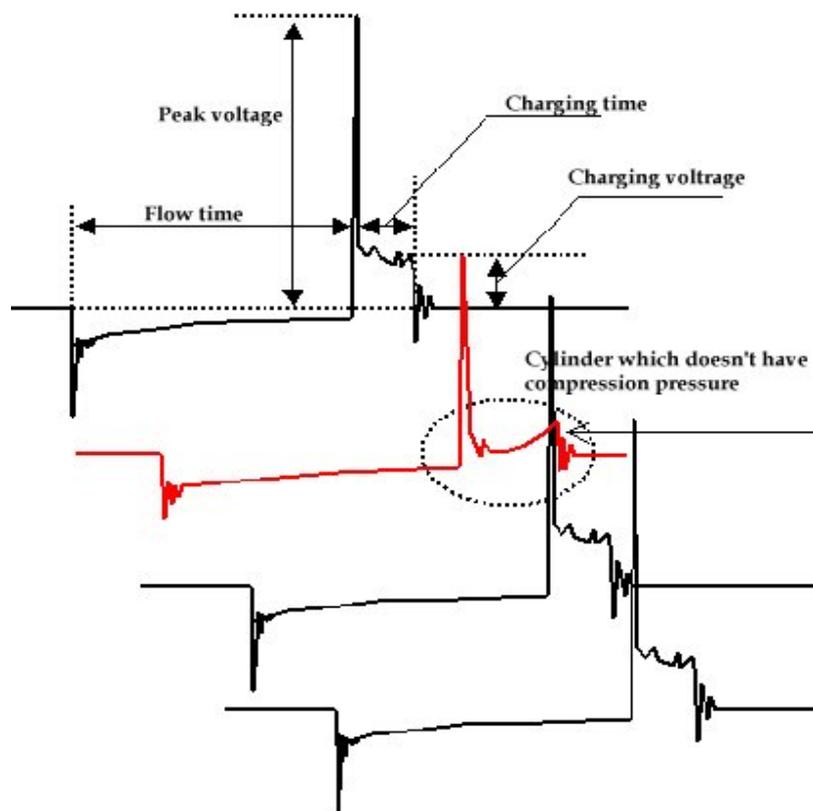
< **Example 3** >

Problem description : RPM is unstable in idle state after engine start. Engine vibration is also happened. The performance is lack when acceleration.

Cause : The carbon is accumulated on stem of intake valve. The intake valve is not closed completely with warmed up engine because valve stem is bigger and bigger with engine warm up. It results in low compression pressure. In case of using adding material to promote research octane number, carbon in element of fuel is accumulated on metal.

The secondary ignition signal of cylinder which is occurred the phenomena has long and low discharging voltage.

Explanation : Low compression pressure makes low discharging energy of secondary ignition signal. If discharging energy is low, energy that is conducted to secondary ignition coil is completely exhausted and need long time. Therefore discharging voltage is low and time is long.
