### 3 The trouble check of TPS signal

#### 1. Troubles

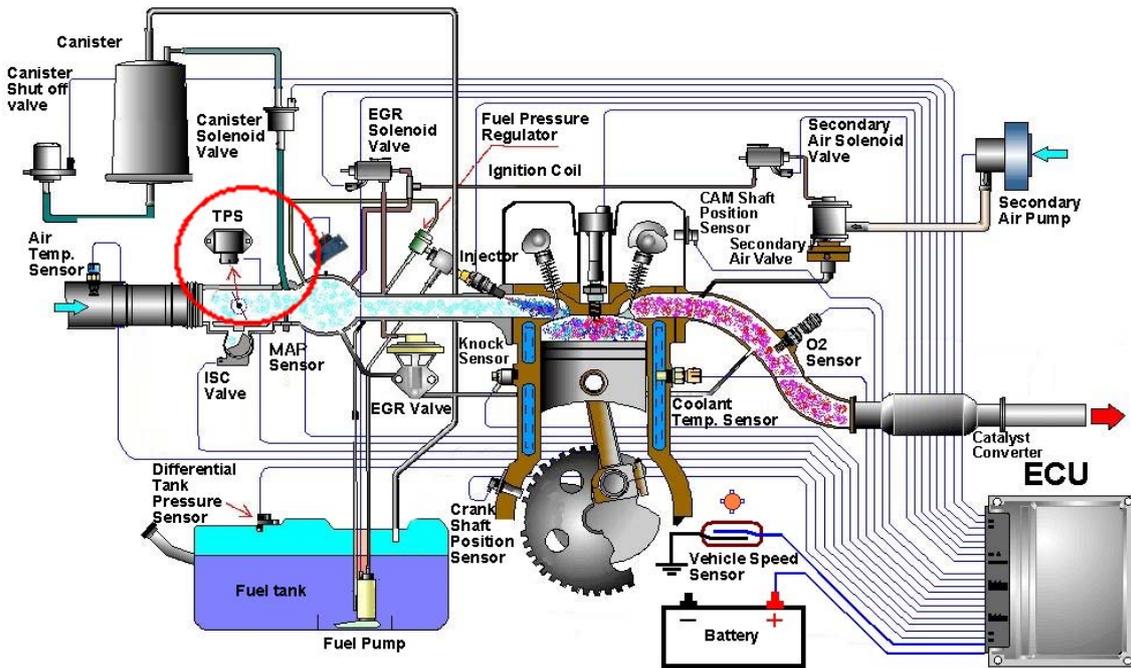
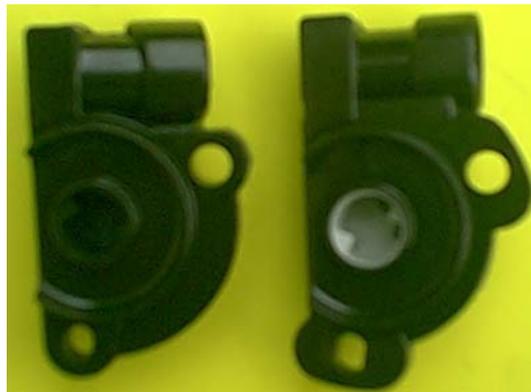
< TPS : Throttle Position Sensor >

### 3. Location of TPS

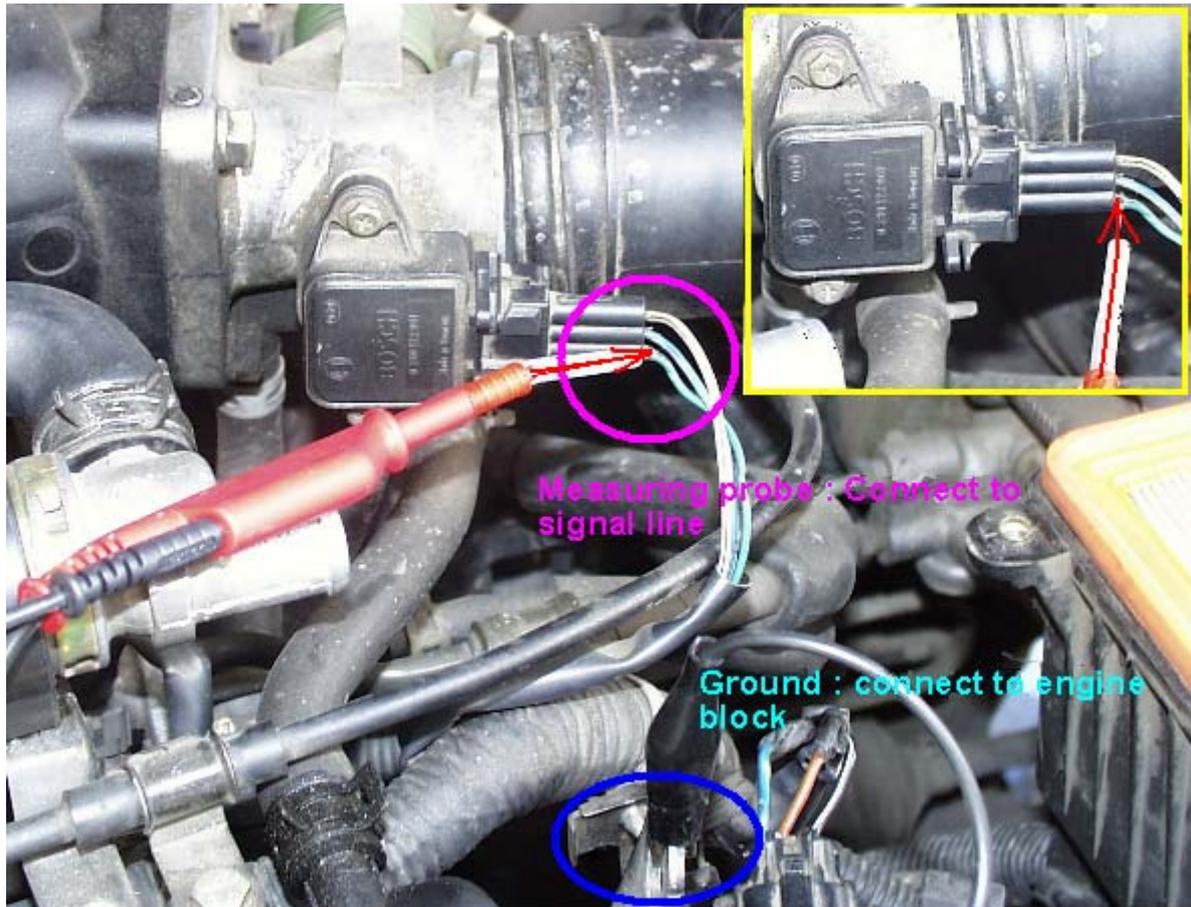
##### 1. Check method

- (1) Check that IDLE state is well recognized through the Scanner.
- (2) Check that TPS signal value changed exactly according to Throttle variation.
- (3) Check that TPS adaptation value is learnt well in IDLE state.

Reference : To measure the signal, ground line should be earth to chassis or engine.

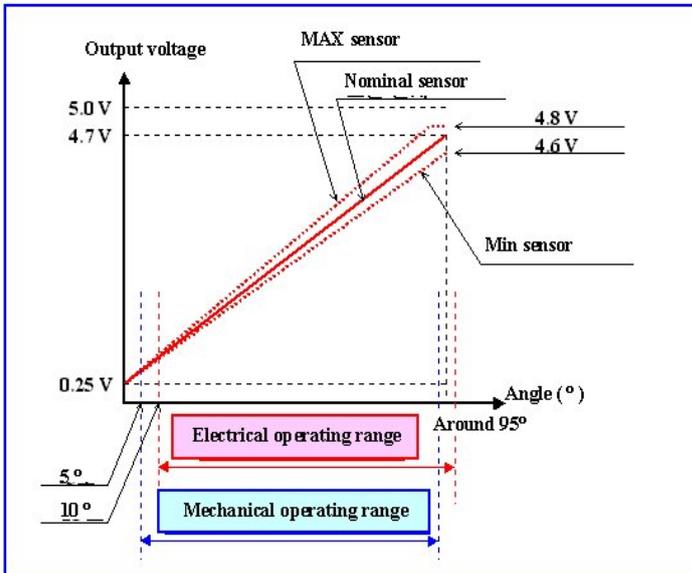
< Spec. : Specification which used during development period >

Check the output voltage according to the pedal opening degree.

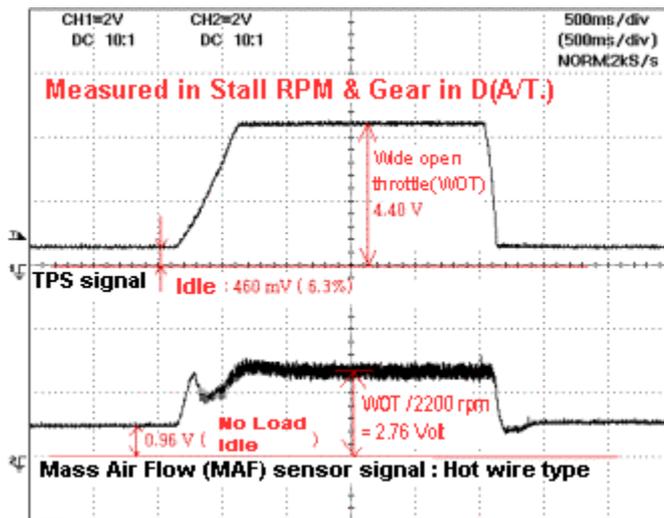
< Measurement : Measure the mass air flow and TPS during full acceleration from idle >

ECU recognized TPS signal check is essential. Through the scanner, TPS value vs. TPS adapted value check is required during idle. If TPS value is bigger (around 1.2) than adapted value, engine idle can be unstable due to ECU not recognized idle status.

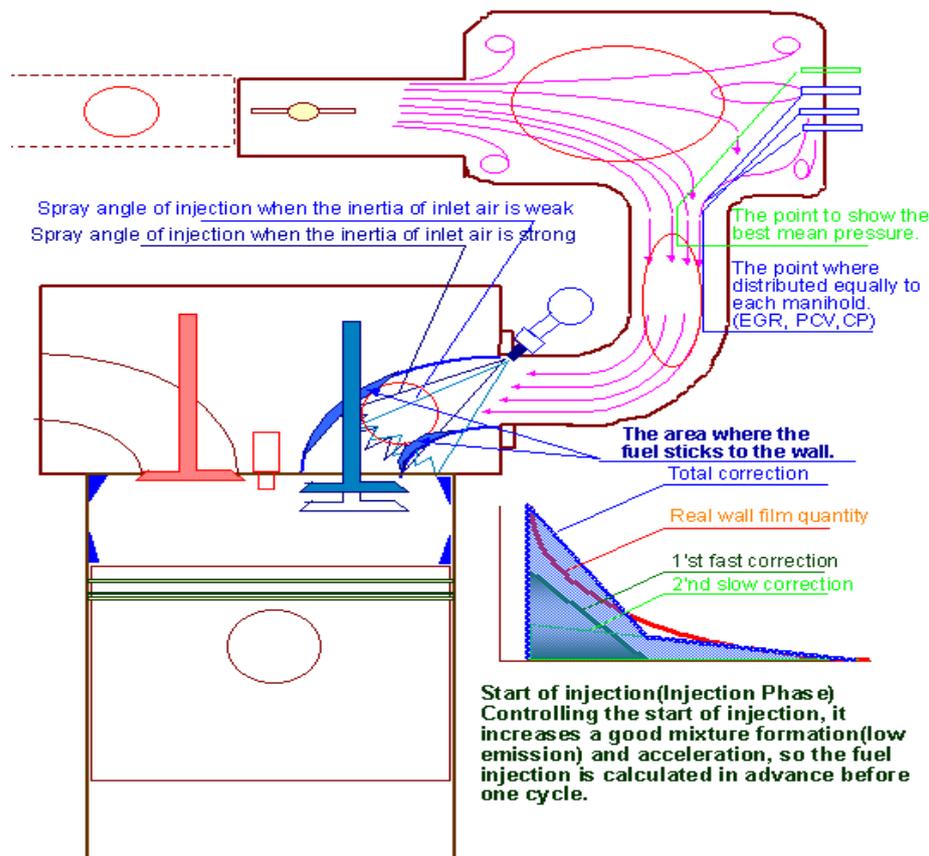
Figure 2 : Wall film phenomenon.

But in case of sudden acceleration or deceleration, most of fuel is wetted on intake inside (at accel) or reverse to this, most of fuel go into the cylinder (at decel)

Therefore supplied fuel during accel or decel phase can be bigger or smaller than supplied air quantity. So, in order to prevent lean or rich fuel during accel or decel phase, accel / decel compensation is performed. And TPS movement must be checked for this compensation. That is to say, If TPS value is increasing, it is detected as 'acceleration' and 'plus fuel compensation' is occurred or if TPS value is decreasing then 'deceleration' is detected and 'minus fuel compensation' is performed.
