8. The signal check of ISC

1. Troubles

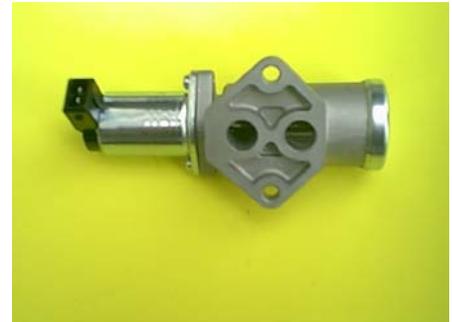
3. Location of ISC valve

< ISC Valve : Duty type(left, right) and Step type(center) >
